Technical Memorandum 4

NSMCSD Collection System Capacity Evaluation/Assurance, Management and Improvement Plan

Subject: Task 4: Condition Assessment and Rehabilitation Program
Recommendations

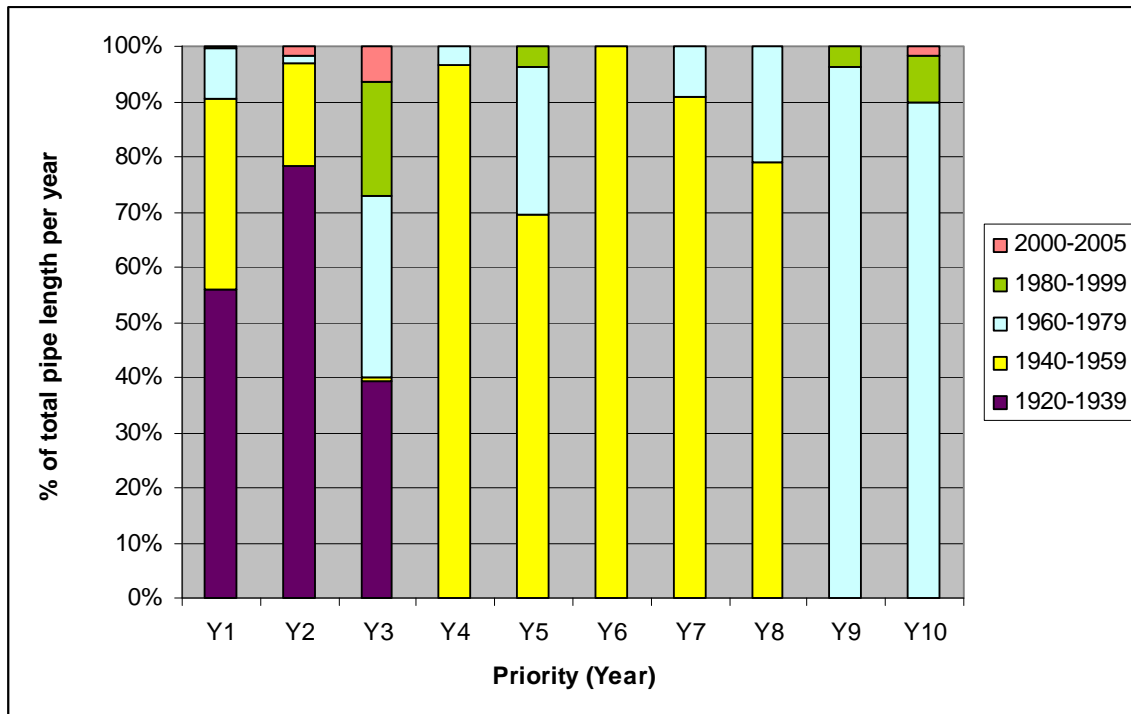
Figure 3: Composition of Pipe Ages for CCTV Areas

Based on the methodology presented above, the schedule presented in **Figure 2** will allow for complete system inspection within 10 years. The characteristics for each area are summarized in **Table 3** and **Figure 3**. A list of all pipe segments to be inspected in the first year of the program is included as **Attachment F**.

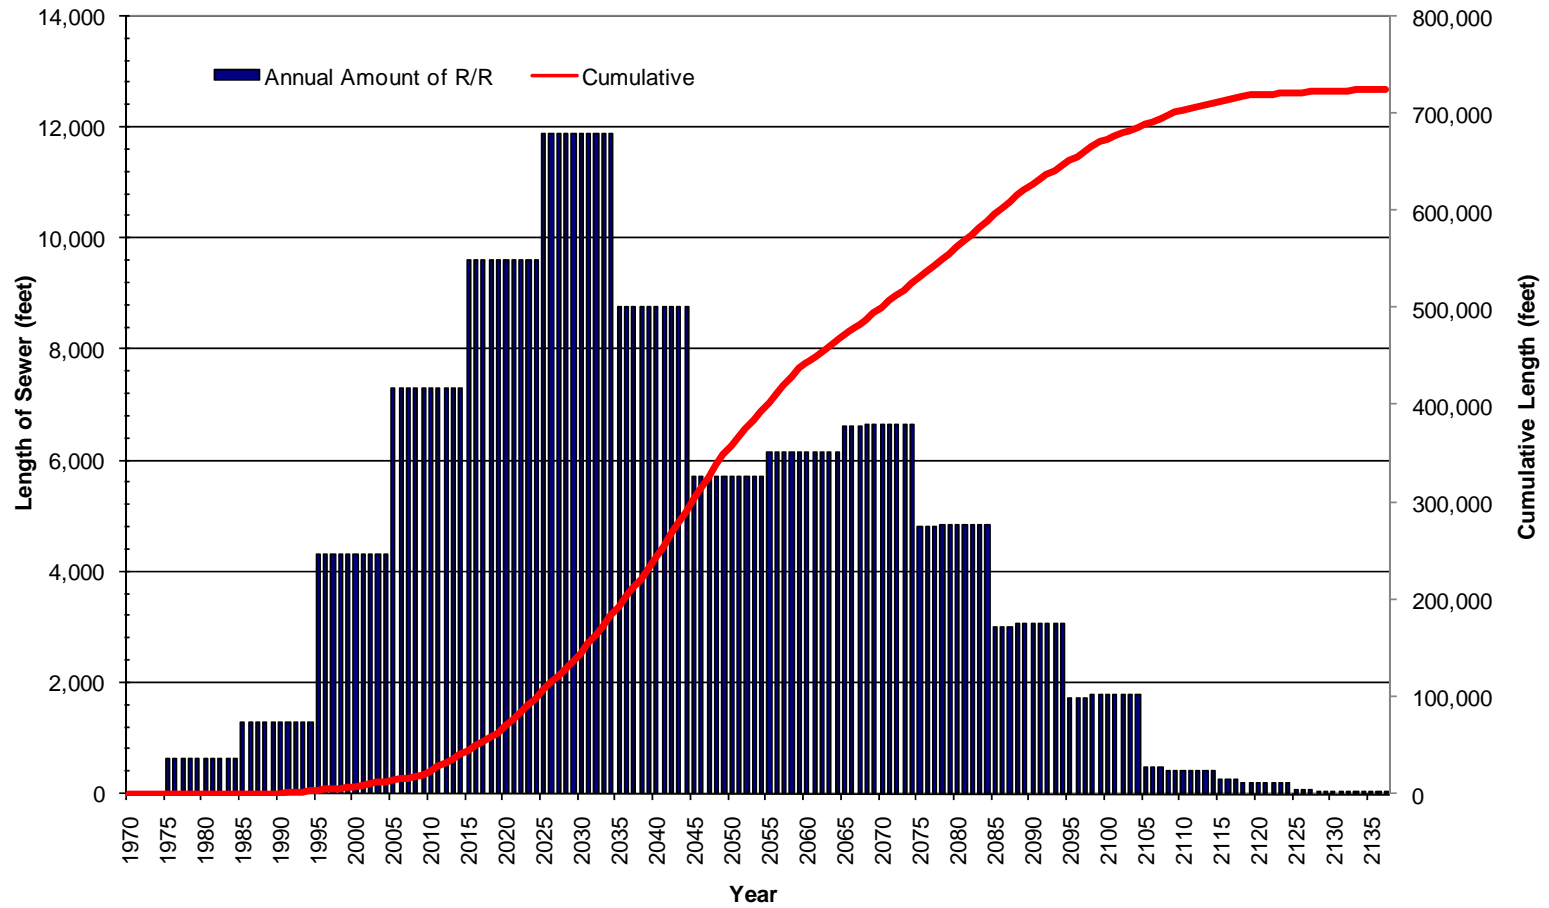
Figure 5: Total Projected Length of Annual Pipe Renewal

Using these assumptions, estimates of the long-term repair, rehabilitation, and replacement needs for the NSMCSD wastewater collection system are presented in Figures 5 through 7. **Figure 5** shows the projected annual and cumulative length of pipe projected to be repaired, lined, or replaced. **Figure 6** shows the projected annual and cumulative construction costs of pipe renewal corresponding to the annual footages in the previous figure. **Figure 7** shows the projected annual and cumulative capital costs of pipe renewal. For this TM, capital costs assume an allowance of 25 percent of construction costs for engineering and other administrative and legal costs.
